SAS Superstructure

Daily Diary Report by Bid Item

Diary #: 420 Const Calendar Day: 143 Date: 25-Oct-2012 Thursday

04-0120F4
04-SF-80-13.2/13.9
Self-Anchored
Suspension Bridge

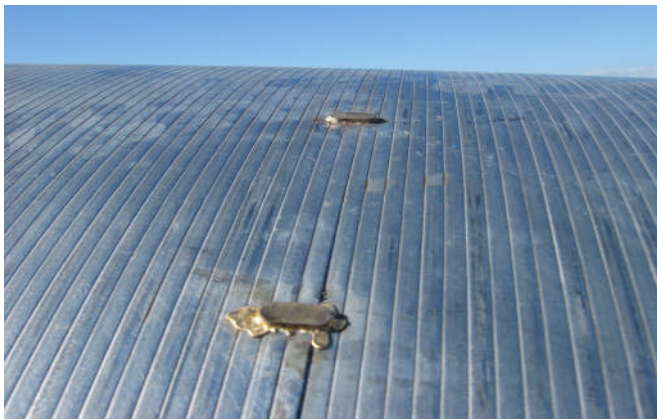
- At 09:20, the wrapping in the North main-span was on hold because of an issue in an area of the S-wire that may not be properly seated into the groove of the adjacent S-wire. I looked at the area along with Victor Pereyra & John Lyons. The S-wire was aligned properly, but not fully seated into the groove. The S-wire in this area was slightly bent, & it could have been an area where there was a shop splice. The area was hit down with a mallet until the S-wire seated down into the groove. In case this area was a shop splice, we asked that they also add 2 adwelds to secure these S-wires. See attached photo.

Cadwelds placed across S-wires to secure the S-wires in place, then ground to about 3mm in height

- From 11:30 until 11:45, Cadwelds were placed on the S-wires near the top of the Cable to secure the S-wires in place. - Note: they did not cut the S-wire, but plan to switch the bobbins from the "push" machine to the "pull" machine.
